ADEL DESOTO MINBURN

COMMUNITY SCHOOL DISTRICT

ATHLETIC FACILITY MASTERPLANNING REPORT

Evaluation of Existing Facilities – **Draft 6.14.15**

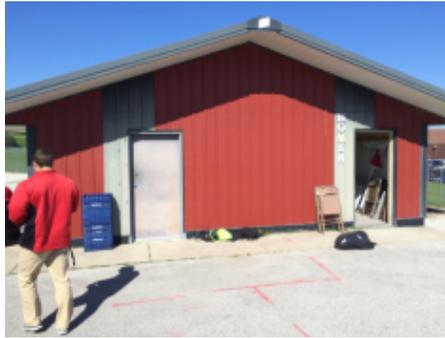
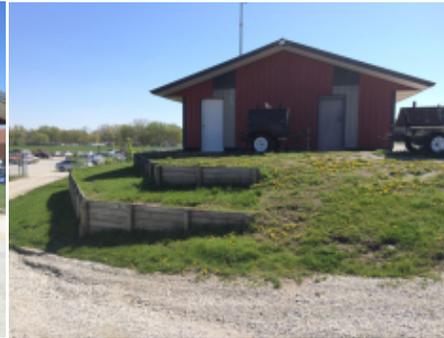
- i. Main pedestrian approach to Stadium: good visibility to stadium entrance. No significant signage announces stadium.
- ii. No clear signage to other athletic venues on site
- iii. No clear signage to concessions at any locations
- iv. Ticket sales at all venues are provided as needed. No fixed ticket booths present.
- v. Poor signage to toilet rooms

Toilet Room Signage

- v. Stadium needs enhance wayfinding
 - vi. Storage is inadequate
 - vii. Officials do not have adequate facilities
 - viii. Field does not have a convenient team room

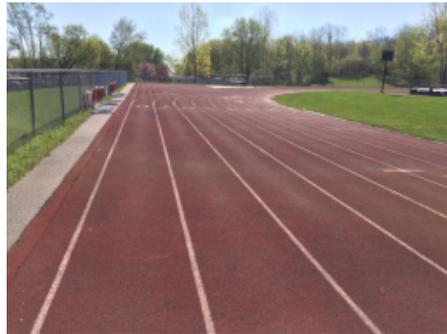
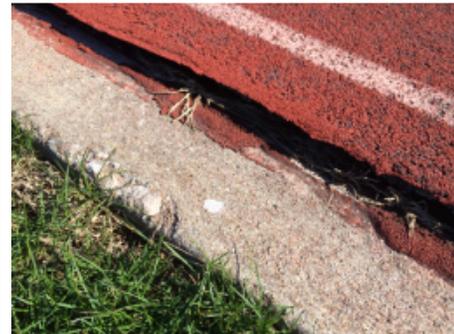
Condition: unacceptable

- i. 8 Lane asphalt track – poor condition, recent temporary repairs made

Images of track

7. District Athletic Program Deficiencies
- a. Stadium
 - i. Track, long jump and high jump need to be replaced
 - ii. Field needs to be reshaped and upgraded

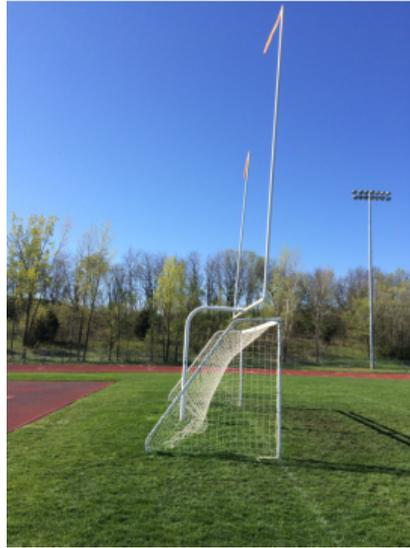
Soccer net under upright

- vii. Metal 20' high goal posts, painted white, orange faded flags, fixed anchorage, fair condition. Horizontal bar not deep enough to adequately accommodate soccer goal, presents hazard at back of net.
- viii. Play clocks at each D zone, hard wired, approximately 10' high, good condition.
- ix. 9' perimeter fence along north side of stadium

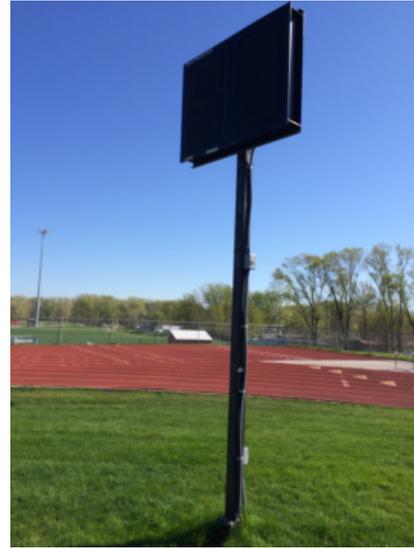
Play clock

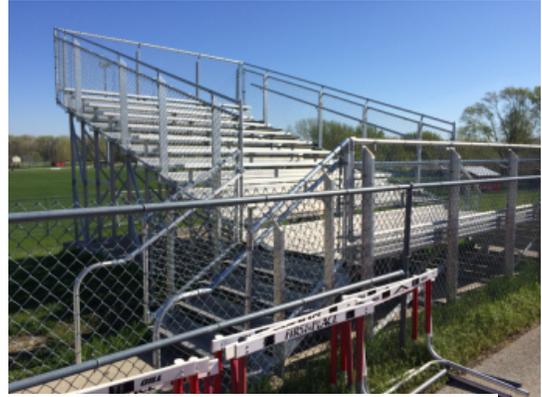
1. Transportable grandstand construction on concrete slab– steel angle framed support structure on slab on grade with aluminum deck and seats
2. 9 rows, 1 bleacher access aisle, 5' wide main front aisle, 3' above grade
3. Stair access at each end

Auxiliary home bleachers

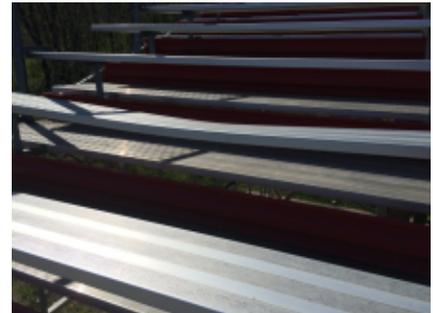
1. Transportable grandstand construction on concrete slab– steel angle framed support structure on slab on grade with aluminum deck and seats
2. 16 rows, 3 bleacher access aisles, 6' wide main front aisle 3' above concrete slab
3. Stair access at each end.
4. Two sections of benches are buckled and need repair.

Visitor bleacher bent seat

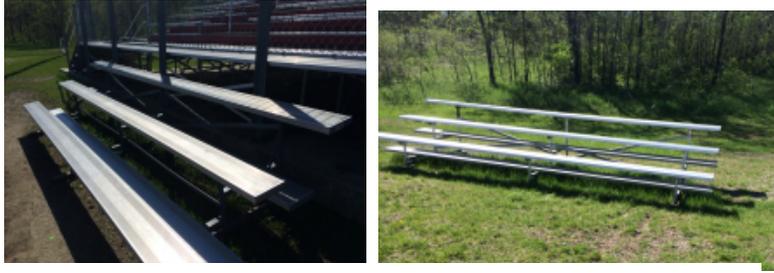
1. Transportable – aluminum angle framed support structure on blocks with aluminum deck and seats
2. 3 rows

Visitor bleacher auxiliary bleachers (also used by band on home side during foot ball season)

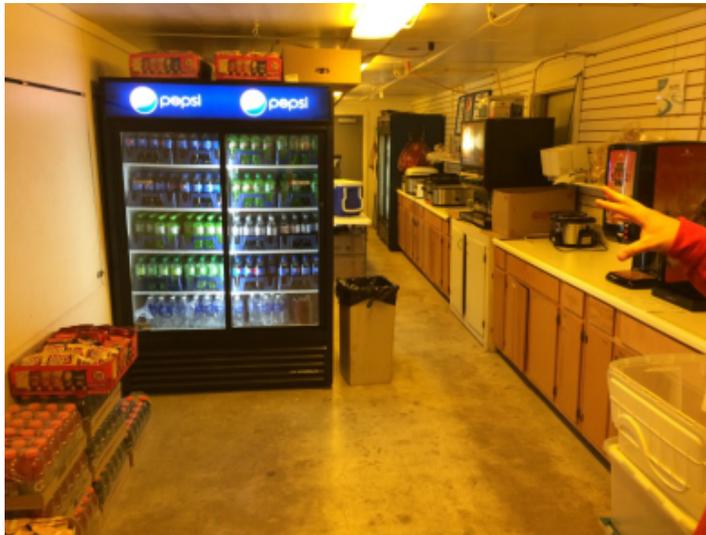
- i. Construction: preformed prefinished metal siding over wood frame on slab on grade, HM service doors, wood tilt up serving doors, metal panel gable roof, sealed concrete floors.

Interior of stadium concessions

- ii. 25' wide by 50' long (1,250 SF)
- iii. Concessions:
 - 1. Four serving doors in use.
 - 2. 24' of wood base cabinets plam countertop, one utility sink with hot and cold water, various mobile counters and tables, 5 reach-in coolers, cappuccino machine, cocoa machine, popcorn maker, various crock pots and roasters

- iii. Concessions and Toilet rooms need to be upgraded and expanded. Ideally, facilities for visitors need to be provided
 - iv. Stadium needs to be made fully ADA compliant

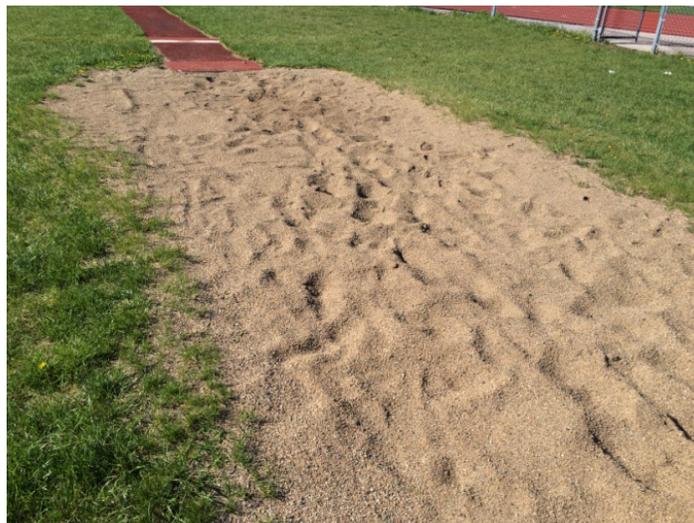
i. Long Jump **Condition: poor**
i. Two opposing asphalt runs, 75' each, sand pits

Sand pit at long jump

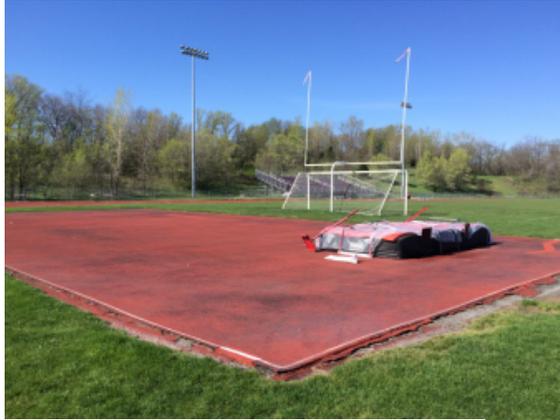
j. High Jump **Condition: poor**
i. At east D zone, asphalt pad

Asphalt at high jump

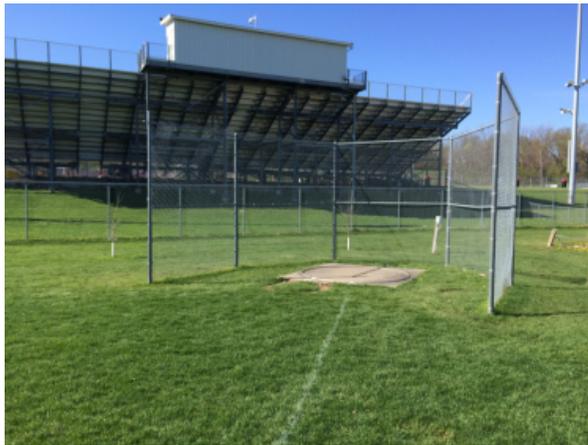
- i. Located in SW corner of south practice field. Decently accessible from stadium
- ii. Chain link fence protection for spectators
- iii. Single concrete launch pad, district would prefer more than one.

Discus pad

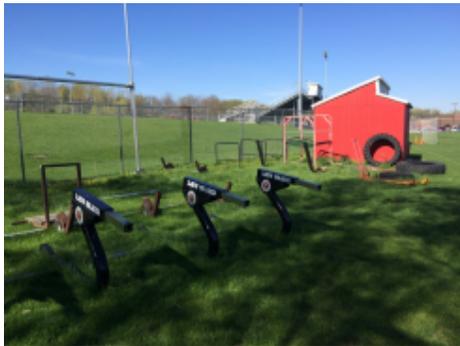
- i. Irrigated
- ii. 4' higher than north practice field
- iii. One permanent goal at west end (poor shape and not needed)
- iv. Used for varsity football and soccer practice and PE classes.
- v. Discus located in SW corner
- vi. Storage building located in SE corner
- vii. Various soccer and football equipment exterior storage in SE corner

Storage area at southeast corner

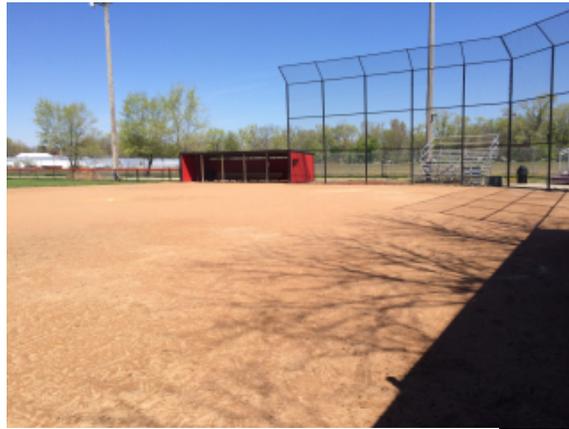
- i. Oriented facing SW
- ii. Irrigated
- iii. Used for varsity softball
- iv. Ag Lime infield, natural grass outfield
- v. Newer black vinyl chain link fencing and red protective top rail plastic cover

Varsity softball field

- vi. Access gate for infield grooming in SE corner of outfield (should be directly to infield)
- vii. Scoreboard outside center field (excellent shape)
- viii. Yellow painted foul ball markers (excellent shape)
- ix. Bull pen located outside left field. No fence on east or south sides, low fence on west.
- x. No bull pen at visitor dugout (north)

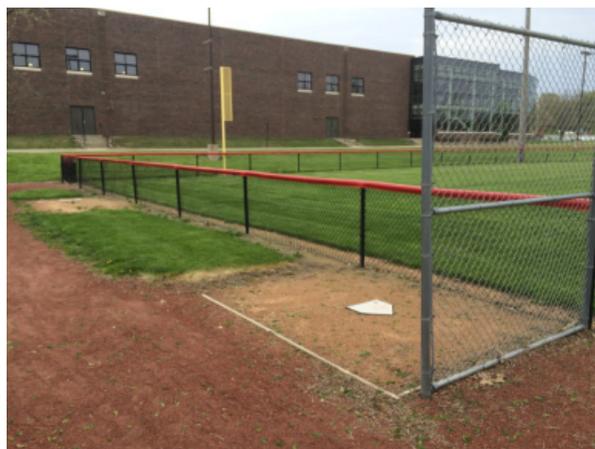
Varsity softball field east bull pen

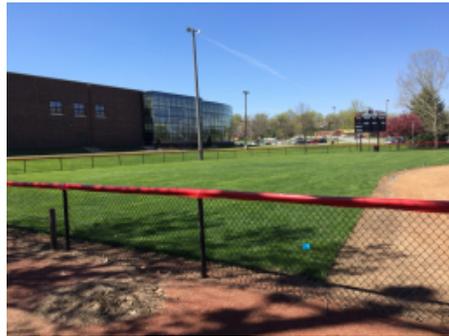
Condition: poor

- i. Dated lights on wood poles
- ii. Power updated in 2014
- iii. Inadequate lighting provided

Varsity softball lighting

- i. Lighting needs to be improved
 - ii. Adequate toilet facilities lacking
 - iii. Site drainage issues should be address
 - iv. Bull pen for varsity baseball should be provided

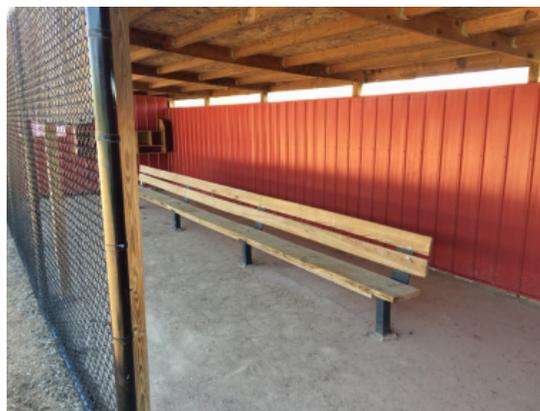
- i. Construction: preformed prefinished metal siding over wood frame, preformed prefinished metal panels over plywood shed roof, concrete slab on grade, chain link fencing front, wood storage cubbies, wood benches with backs.

Varsity softball east dugout

- ii. 12' wide by 36' long
- iii. East dugout has no water or electricity
- iv. East dugout has drainage issues, it is slightly lower than the field.
- v. West dugout has water, no electricity

- ix. Water and electric service should be provided for all dugouts
 - x. Junior varsity ball field needs field work.
 - xi. Proper infield grooming access should be provided for all fields.

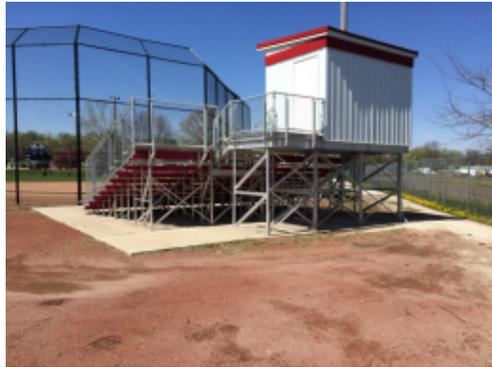
- i. Construction
 - 1. Transportable grandstand construction on concrete slab–aluminum framed support structure on slab on grade with

aluminum deck and seats. Vertical seating skirts have faded to pink.

- 2. 10 rows, 1 bleacher access aisle
- ii. Capacity
 - 1. **120** at 22" width per spectator
 - 2. **140** at 18" width per spectator
- iii. 120 SF metal sided press box with metal shed roof, slider windows, and HM service doors.

Varsity softball bleachers and press box

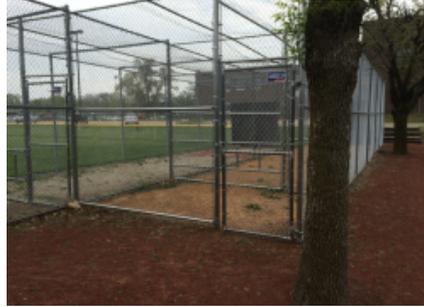
- g. Softball Batting Cages **Condition: excellent**
 - i. 10'high chain link fencing, top netting
 - ii. Minor roof repair required

Softball field batting cage

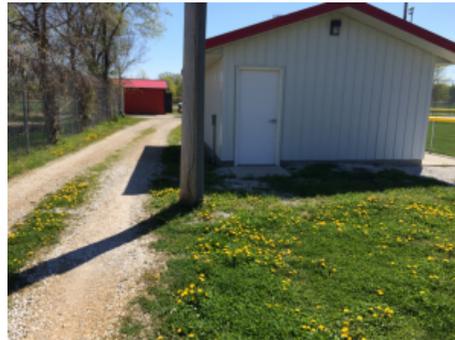
- i. Construction: preformed prefinished metal siding over wood frame on slab on grade, HM service doors, metal service, metal panel gable roof, sealed concrete floors.
- ii. 16' wide by 20' long (320 SF)
- iii. Storage space inadequate
- iv. Located north of Middle School softball field

Ball field concessions

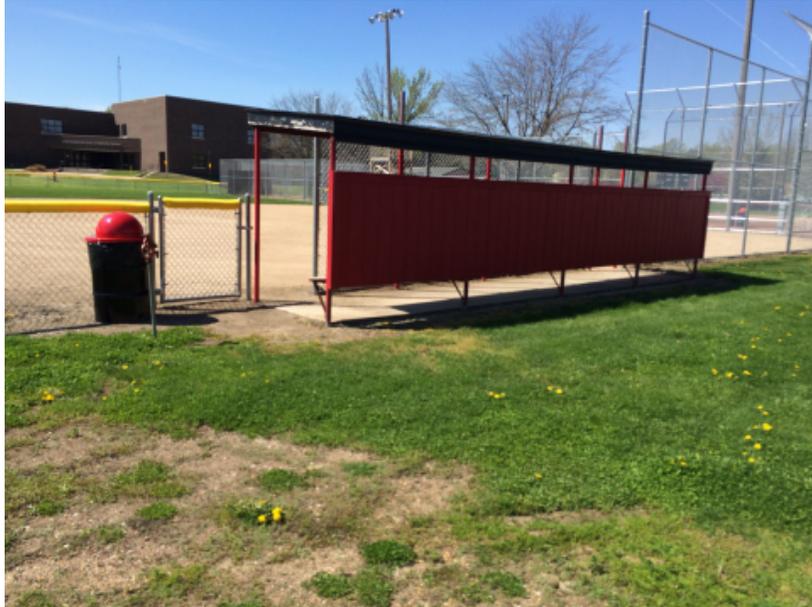
- i. Oriented facing SE
- ii. Used for junior varsity softball and marching band practice
- iii. Ag Lime infield, natural grass outfield
- iv. Newer galvanized chain link fencing and yellow protective top rail plastic cover

Middle School softball field

- v. Access gate for infield grooming in SE corner of outfield (should be direct to infield)
- vi. Scoreboard outside center field (unacceptable)
- vii. Yellow painted foul ball markers (fair shape)
- viii. Marching band wooden crow's nest outside right field

- v. Additional storage would be helpful
 - vi. Baseball batting cages should be improved
 - vii. Auxiliary practice field needs to be improved
 - viii. Junior varsity scoreboards should be replaced

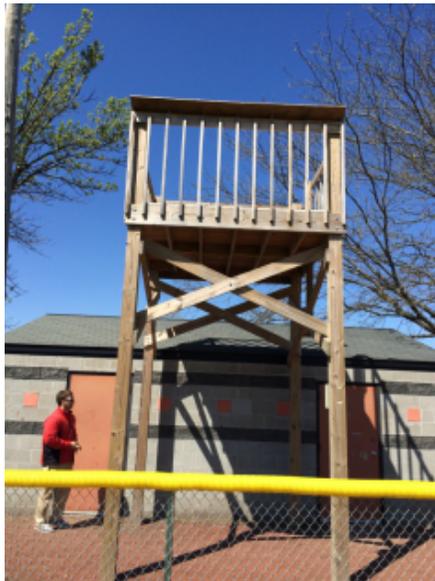
Marching band crow's nest

- d. Marching Band practice
 - i. An alternative location for Marching band practice would be helpful to avoid damage to the junior varsity softball field.

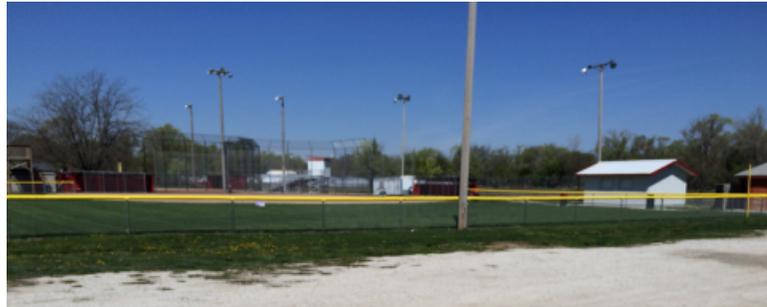
- d. Middle School Softball Lighting
 - i. Dated lights on wood poles
 - ii. Inadequate lighting

Condition: unacceptable

Middle School softball field lighting

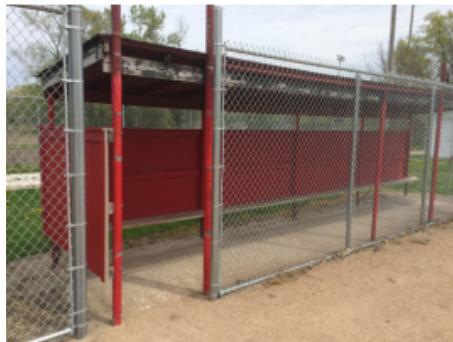
- e. Junior Varsity Softball Dugouts
 - i. Construction: wood panels or slats siding over wood frame and metal posts, asphalt shingles over plywood shed roof, concrete slab on grade, chain link fencing front, wood benches.

Middle School softball dugouts - dugout

- ii. 5'-6" wide by 28'-8" long
- iii. West dugout has electricity, no water
- iv. North dugout has water, no electricity

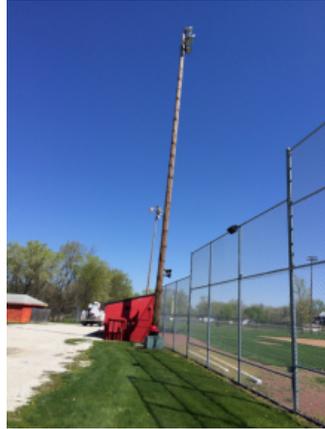
- i. Varsity Baseball Lighting
 - i. Dated lights on wood poles
 - ii. Inadequate lighting

Condition: unacceptable

Varsity baseball lighting

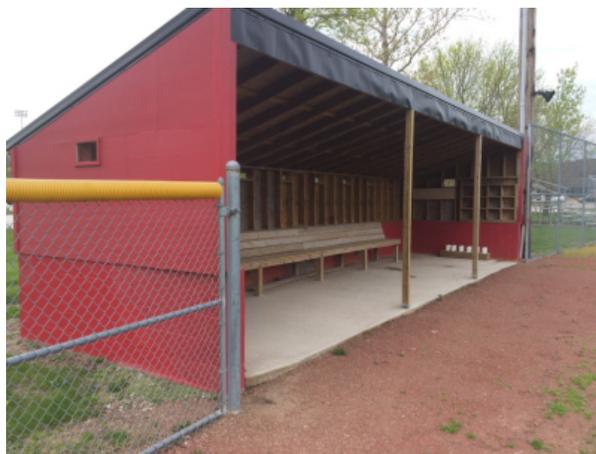
- j. Varsity Baseball Dugouts
 - i. Construction: preformed prefinished metal siding over wood frame, preformed prefinished metal panels over plywood shed roof, concrete slab on grade, chain link fencing front, wood storage cubbies, wood benches with backs.

Varsity dugout - south dugout

- ii. 12' wide by 36' long
- iii. Each dugout has water, no electricity
- iv. No fence in front of dugouts

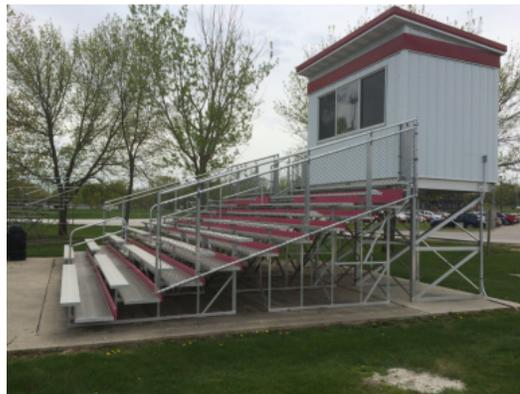
1. Transportable grandstand construction on concrete slab—aluminum framed support structure on slab on grade with aluminum deck and seats. Vertical seating skirts have faded to pink.
2. 10 rows, 1 bleacher access aisle

- iii. 120 SF metal sided press box with metal shed roof, slider windows, and HM service doors.

Varsity baseball bleacher and press box

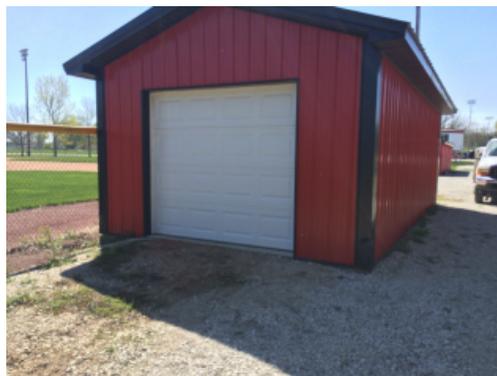
1. Construction: preformed prefinished metal siding over wood frame on slab on grade, HM service doors, metal service, metal panel gable roof, sealed concrete floors.
2. Constructed in 2011
3. 14' wide by 26' long (432 SF)
4. Inadequately sized

Baseball field storage

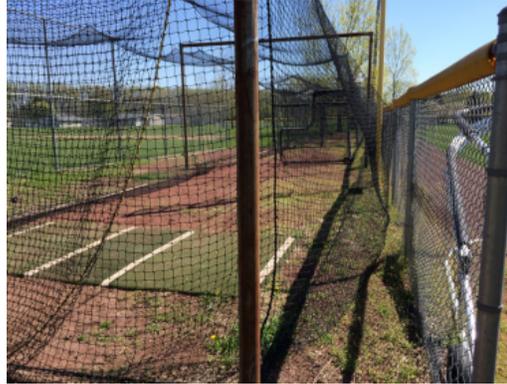
Condition: unacceptable

- i. Located north of field
- ii. 10'high chain link fencing, top and side netting

Baseball field batting cages

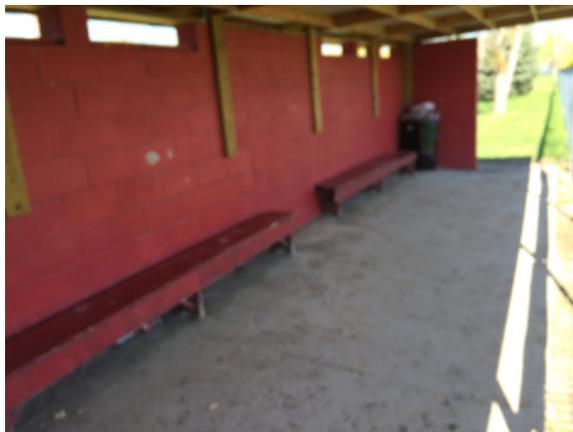
- i. Construction: Single wythe concrete block walls, preformed prefinished metal panels over plywood shed roof, concrete slab on grade, chain link fencing front, wood storage cubbies, wood benches.

Middle School dugouts - south dugout

- ii. 8'-8" wide by 32' long
- iii. Each dugout has water

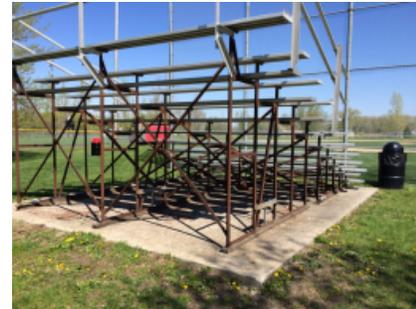
- 1. Transportable grandstand construction on concrete slab–aluminum framed support structure on slab on grade with aluminum deck and seats.

iii. No guardrail

Middle School baseball field bleachers
