ADM Community School District

Athletics Facilities Masterplanning

(October 28, 2015 Draft)

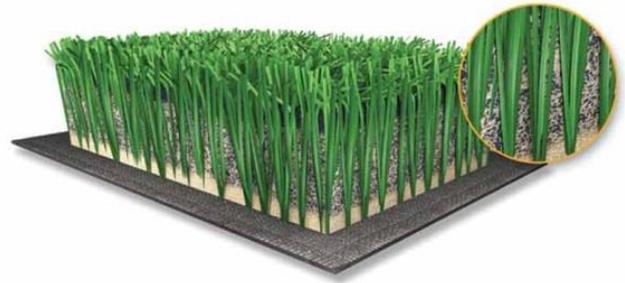
A synthetic turf field is a synthetic turf carpet that has strands of polymer material that mimics natural grass. The carpet mat is perforated allowing water to drain through to a rock sub-base and drain tile below. The strands of grass like material are infilled with a rubber/sand mixture that creates an earthlike quality. There are two distinct types of polymer strands: a monofilament which is a single blade of material and a slit film filament which is a wider blade with slits that fan out. Synthetic turf manufacturers use a variety of granular rubber and sand infill. The district's preferred manufacturer is Tarket FieldTurf, which has two infill systems based on the ratio of the sand to rubber and the resultant weights. The recommended height of the strands of polymer grass material is 2 ½". The cost of replacing the carpet is estimated to be between \$9.00 and \$10.00 per square foot. About 80% of the infill material is able to be reused.

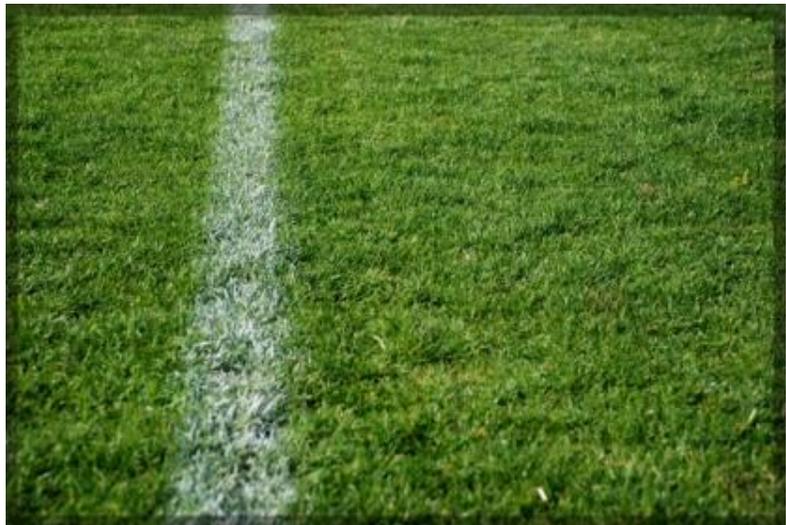
the stadium from being unavailable for use for a year the grass is generally installed as sod rather than seed. A seeded field needs a full year to establish. A natural turf field can accommodate up to 70 games per season when used as both a soccer and a football field. Maintenance costs provided by a professional natural grass maintenance company can cost up to \$30,000 per year excluding mowing and striping. Professional maintenance would include: aerating, over-seeding, sod replacement as required, additional lifts of sand cap material, chemical treatment, and top dressing.

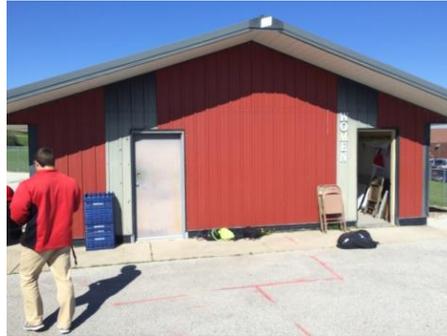
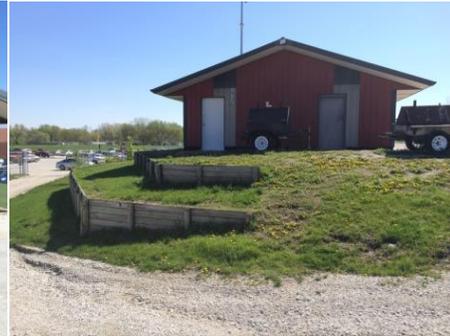
- i. Main pedestrian approach to Stadium: good visibility to stadium entrance. No significant signage announces stadium.
- ii. No clear signage to other athletic venues on site
- iii. No clear signage to concessions at any locations
- iv. Ticket sales at all venues are provided as needed. No fixed ticket booths present.
- v. Poor signage to toilet rooms

Toilet Room Signage

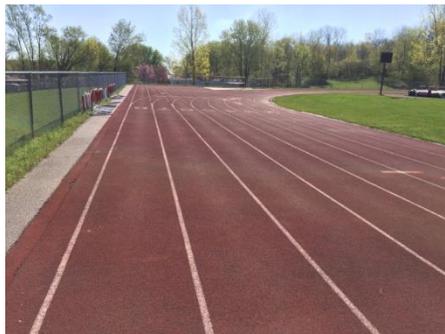
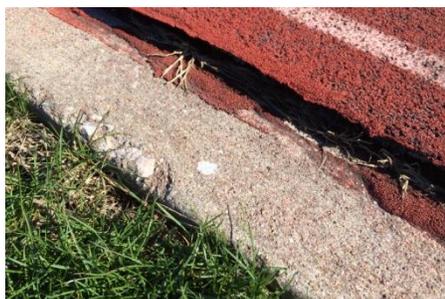
- i. 8 Lane asphalt track – poor condition, recent temporary repairs made

Images of track

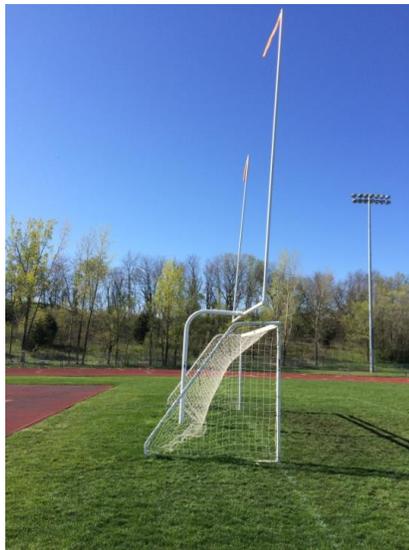
- i. Natural turf field, excessive wear noted. Grass grows better on the east end of field than on the west end of the field. Soils are not ideal at the west half of the field.
- ii. Field is not wide enough for an soccer field of ideal width.
- iii. Field is not crowned properly, water does not shed efficiently
- iv. Field does not have adequate power for band performances and other activities that require power.
- v. Field has a built in sprinkler system than operates adequately.
- vi. Space on sidelines, while not idea, is adequate.

Soccer net under upright

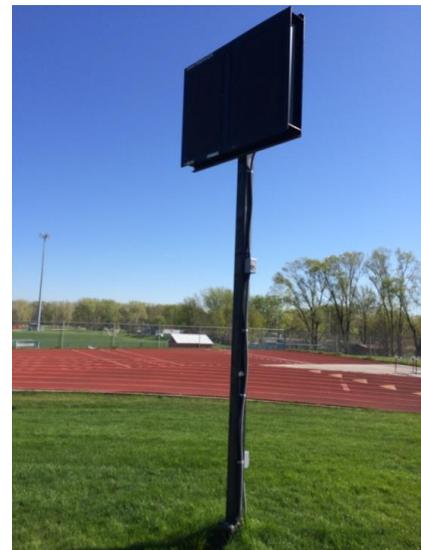
Play clock

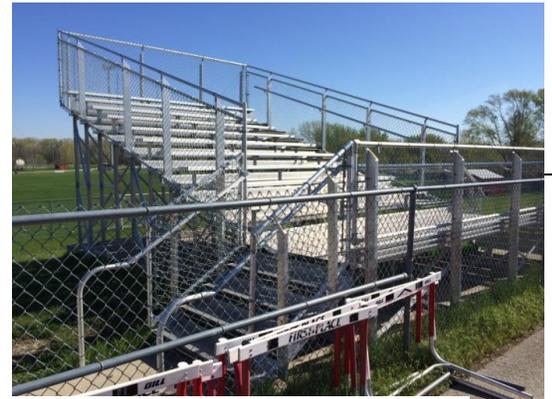
- i. Construction
 - 1. Transportable grandstand construction on concrete slab—steel angle framed support structure on slab on grade with aluminum deck and seats
 - 2. 9 rows, 1 bleacher access aisle, 5' wide main front aisle, 3' above grade
 - 3. Stair access at each end
- ii. Capacity:
 - 1. **66** at 22" width per spectator
 - 2. **82** at 18" width per spectator
 - 3. No ADA seats
- iii. Used for younger grades

Auxiliary home bleachers

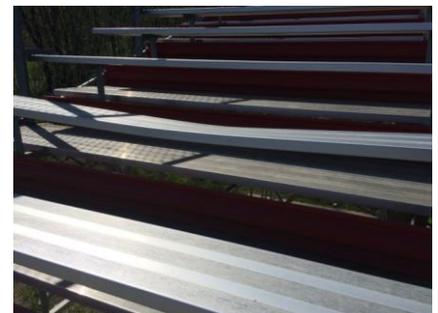
- i. Construction
 - 1. Transportable grandstand construction on concrete slab—steel angle framed support structure on slab on grade with aluminum deck and seats
 - 2. 16 rows, 3 bleacher access aisles, 6' wide main front aisle 3' above concrete slab
 - 3. Stair access at each end.
 - 4. Two sections of benches are buckled and need repair.
- ii. Capacity
 - 1. **726** at 22" width per spectator
 - 2. **887** at 18" width per spectator

Visitor bleacher bent seat

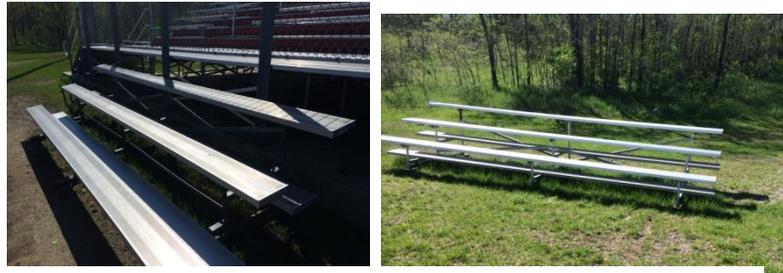
1. Transportable – aluminum angle framed support structure on blocks with aluminum deck and seats
2. 3 rows

Visitor bleacher auxiliary bleachers (also used by band on home side during foot ball season)

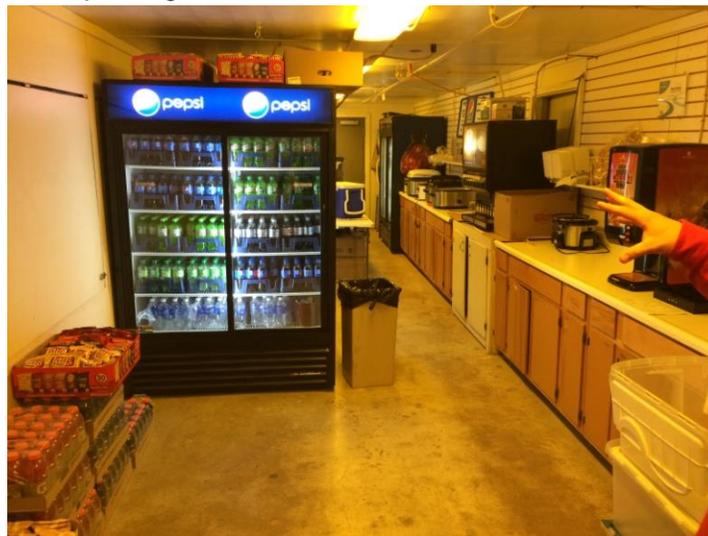
- i. Construction: preformed prefinished metal siding over wood frame on slab on grade, HM service doors, wood tilt up serving doors, metal panel gable roof, sealed concrete floors.

Interior of stadium concessions

- ii. 25' wide by 50' long (1,250 SF)
- iii. Concessions:
 - 1. Four serving doors in use.
 - 2. 24' of wood base cabinets plum countertop, one utility sink with hot and cold water, various mobile counters and tables, 5 reach-in coolers, cappuccino machine, cocoa machine, popcorn maker, various crock pots and roasters

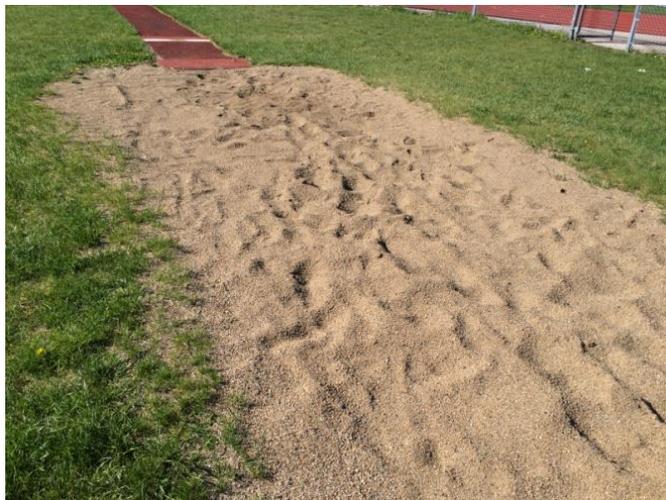
- h. Lighting **Condition: excellent**
 - i. Musco lighting: New 2012
- i. Long Jump **Condition: poor**
 - i. Two opposing asphalt runs, 75' each, sand pits

Sand pit at long jump

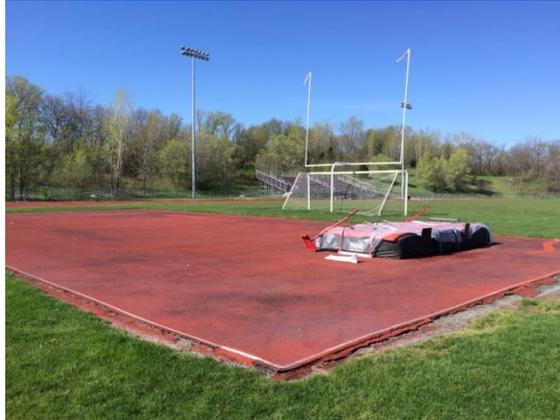
- i. At east D zone, asphalt pad

Asphalt at high jump

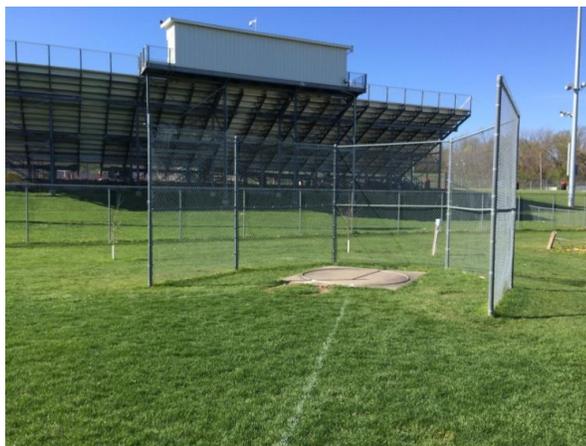
- i. Located in SW corner of south practice field. Decently accessible from stadium
- ii. Chain link fence protection for spectators
- iii. Single concrete launch pad, district would prefer more than one.

Discus pad

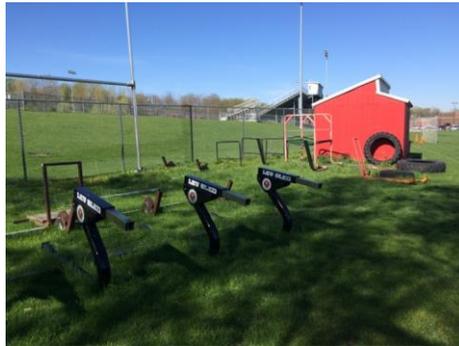
- i. Irrigated
- ii. 4' higher than north practice field
- iii. One permanent goal at west end (poor shape and not needed)
- iv. Used for varsity football and soccer practice and PE classes.
- v. Discus located in SW corner
- vi. Storage building located in SE corner
- vii. Various soccer and football equipment exterior storage in SE corner

Storage area at southeast corner

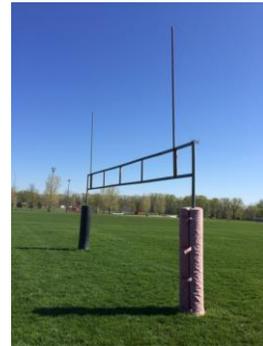
Decommissioned goalpost

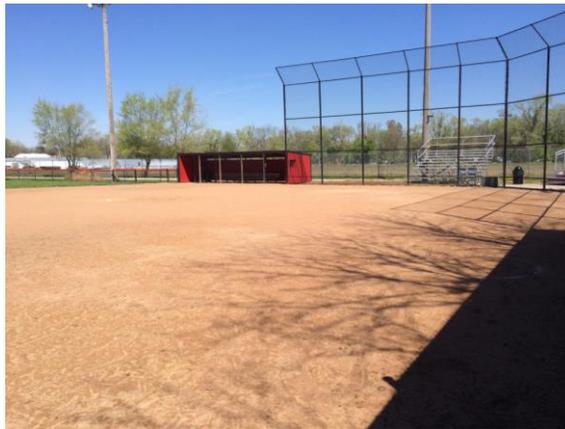
- a. Varsity Softball (west field) **Condition: excellent**
- i. Oriented facing SW
 - ii. Irrigated
 - iii. Used for varsity softball
 - iv. Ag Lime infield, natural grass outfield
 - v. Newer black vinyl chain link fencing and red protective top rail plastic cover

Varsity softball field

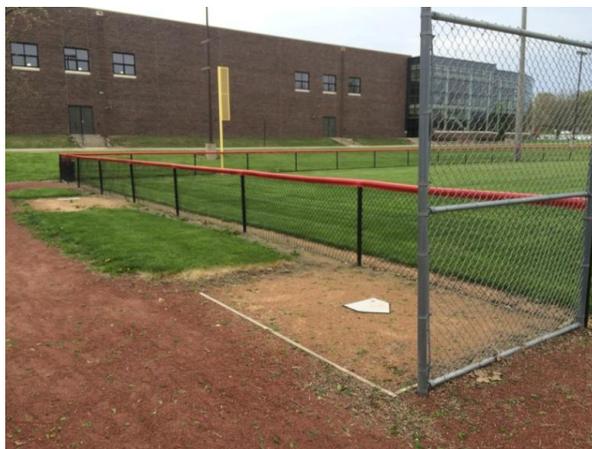
- vi. Access gate for infield grooming in SE corner of outfield (should be directly to infield)
- vii. Scoreboard outside center field (excellent shape)
- viii. Yellow painted foul ball markers (excellent shape)
- ix. Bull pen located outside left field. No fence on east or south sides, low fence on west.
- x. No bull pen at visitor dugout (north)

Varsity softball field east bull pen

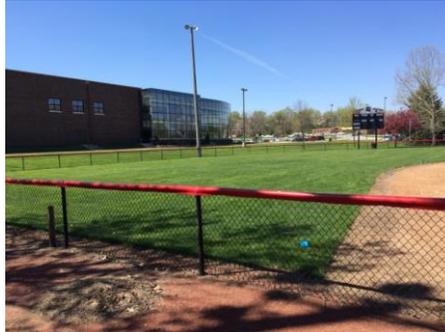
- i. Dated lights on wood poles
- ii. Power updated in 2014
- iii. Inadequate lighting provided

Varsity softball lighting

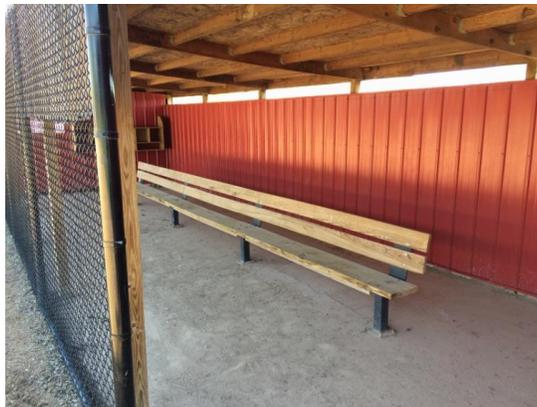
- i. Construction: preformed prefinished metal siding over wood frame, preformed prefinished metal panels over plywood shed roof, concrete slab on grade, chain link fencing front, wood storage cubbies, wood benches with backs.

Varsity softball east dugout

- ii. 12' wide by 36' long
- iii. East dugout has no water or electricity
- iv. East dugout has drainage issues, it is slightly lower than the field.
- v. West dugout has water, no electricity

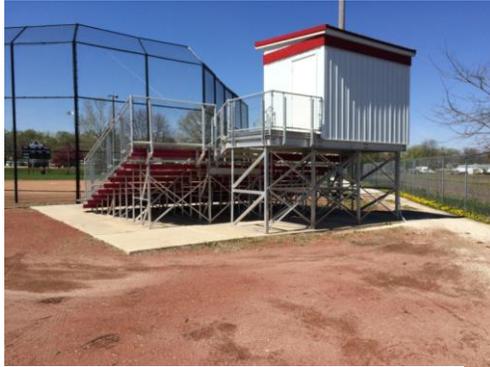
- i. Construction
 - 1. Transportable grandstand construction on concrete slab– aluminum framed support structure on slab on grade with aluminum deck and seats. Vertical seating skirts have faded to pink.

- 2. 10 rows, 1 bleacher access aisle
- ii. Capacity
 - 1. **120** at 22" width per spectator
 - 2. **140** at 18" width per spectator
- iii. 120 SF metal sided press box with metal shed roof, slider windows, and HM service doors.

Varsity softball bleachers and press box

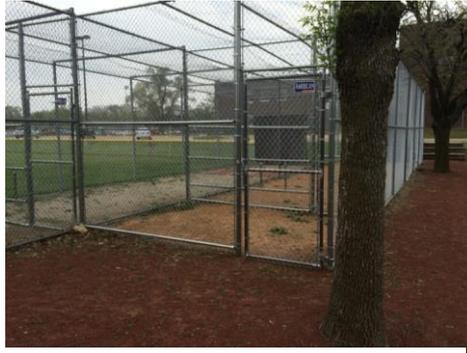
- g. Softball Batting Cages **Condition: excellent**
 - i. 10'high chain link fencing, top netting
 - ii. Minor roof repair required

Softball field batting cage

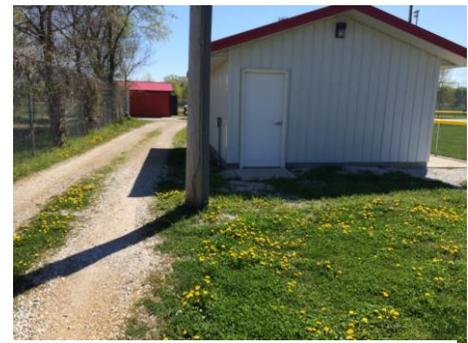
- i. Construction: preformed prefinished metal siding over wood frame on slab on grade, HM service doors, metal service, metal panel gable roof, sealed concrete floors.
- ii. 16' wide by 20' long (320 SF)
- iii. Storage space inadequate
- iv. Located north of Middle School softball field
- v. Completed Fall 2011

Ball field concessions

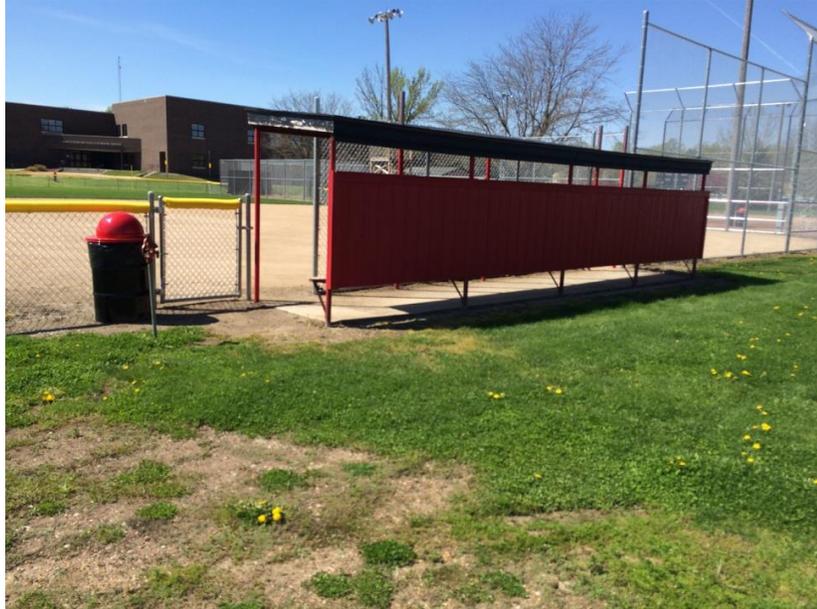
- i. Oriented facing SE
- ii. Used for junior varsity softball and marching band practice
- iii. Ag Lime infield, natural grass outfield
- iv. Newer galvanized chain link fencing and yellow protective top rail plastic cover

Middle School softball field

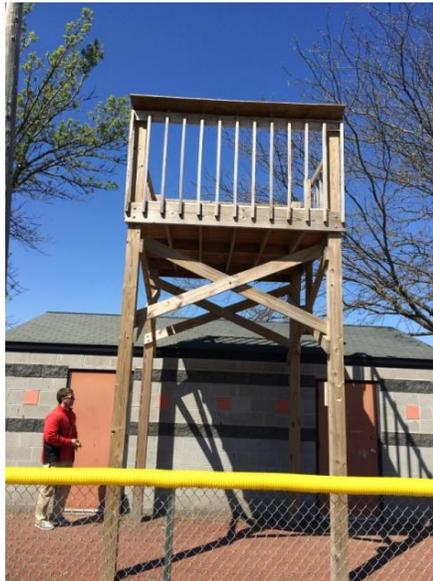
Marching band crow's nest

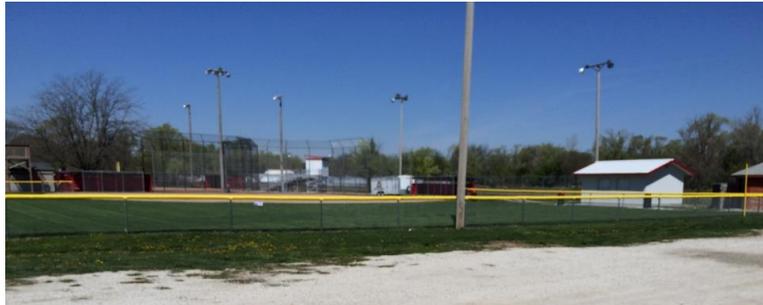
- d. Middle School Softball Lighting
 - i. Dated lights on wood poles
 - ii. Inadequate lighting

Condition: unacceptable

Middle School softball field lighting

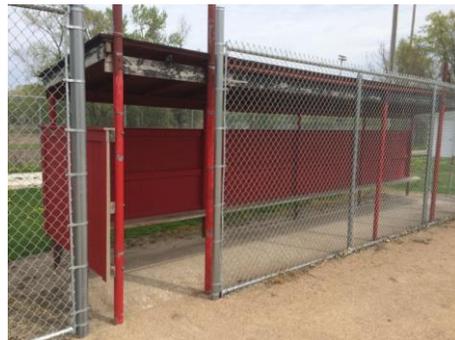
- e. Junior Varsity Softball Dugouts
 - i. Construction: wood panels or slats siding over wood frame and metal posts, asphalt shingles over plywood shed roof, concrete slab on grade, chain link fencing front, wood benches.

Middle School softball dugouts - dugout

- ii. 5'-6" wide by 28'-8" long
 - iii. West dugout has electricity, no water
 - iv. North dugout has water, no electricity
- f. Junior Varsity Softball Stands – non present

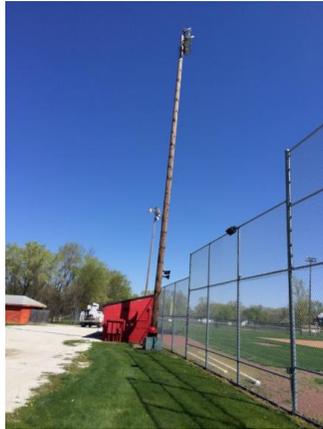
- i. Varsity Baseball Lighting
 - i. Dated lights on wood poles
 - ii. Inadequate lighting

Condition: unacceptable

Varsity baseball lighting

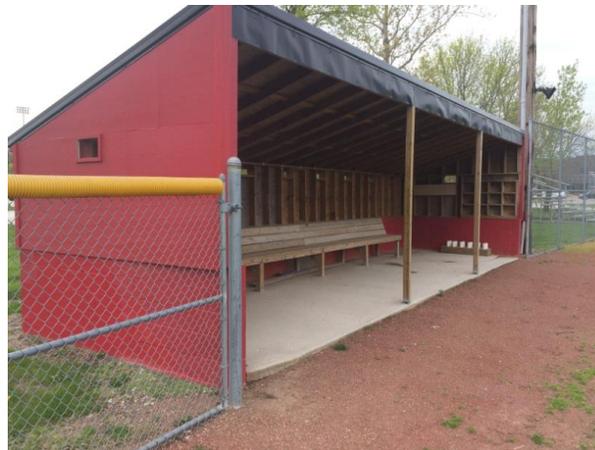
- j. Varsity Baseball Dugouts
 - i. Construction: preformed prefinished metal siding over wood frame, preformed prefinished metal panels over plywood shed roof, concrete slab on grade, chain link fencing front, wood storage cubbies, wood benches with backs.

Varsity dugout - south dugout

- ii. 12' wide by 36' long
- iii. Each dugout has water, no electricity
- iv. No fence in front of dugouts

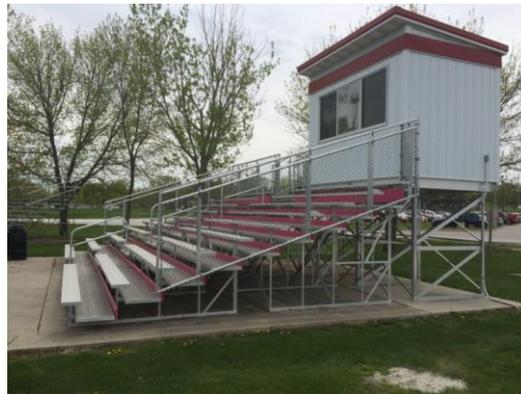
- iii. 120 SF metal sided press box with metal shed roof, slider windows, and HM service doors.

Varsity baseball bleacher and press box

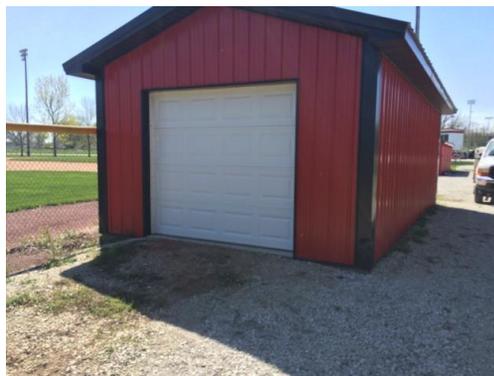
1. Construction: preformed prefinished metal siding over wood frame on slab on grade, HM service doors, metal service, metal panel gable roof, sealed concrete floors.
2. Constructed in 2011
3. 14' wide by 26' long (432 SF)
4. Inadequately sized

Baseball field storage

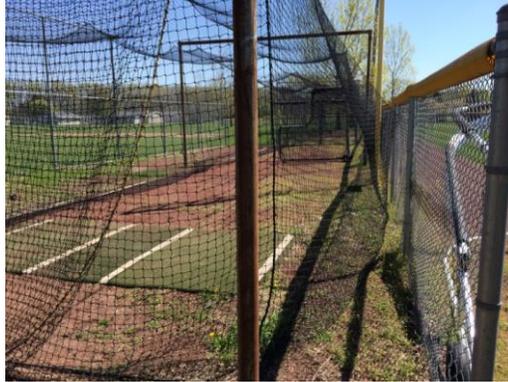
Condition: unacceptable

- i. Located north of field
- ii. 10'high chain link fencing, top and side netting

Baseball field batting cages

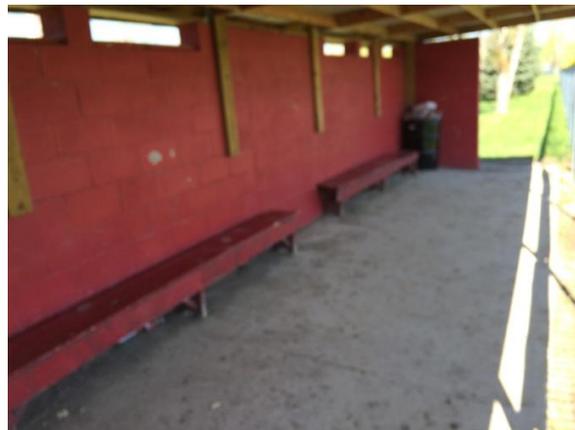
- i. Construction: Single wythe concrete block walls, preformed prefinished metal panels over plywood shed roof, concrete slab on grade, chain link fencing front, wood storage cubbies, wood benches.

Middle School dugouts - south dugout

- ii. 8'-8" wide by 32' long
- iii. Each dugout has water

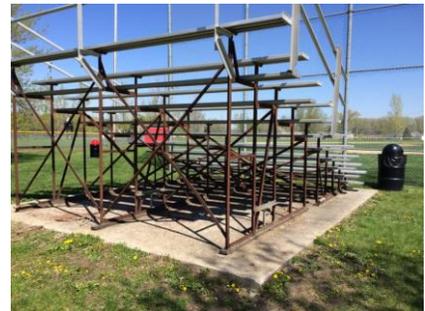
- i. Construction
 - 1. Transportable grandstand construction on concrete slab– aluminum framed support structure on slab on grade with aluminum deck and seats.
- ii. Capacity
 - 2. **80** at 22" width per spectator
 - 3. **100** at 18" width per spectator
- iii. No guardrail

Middle School baseball field bleachers
